ASBESTOS SURVEY REPORT

(Refurbishment / Demolition Survey)

**Location: The Old Rialto Cinema Site,
South Circular Road, Dublin 8**

Report No. PE 18-475

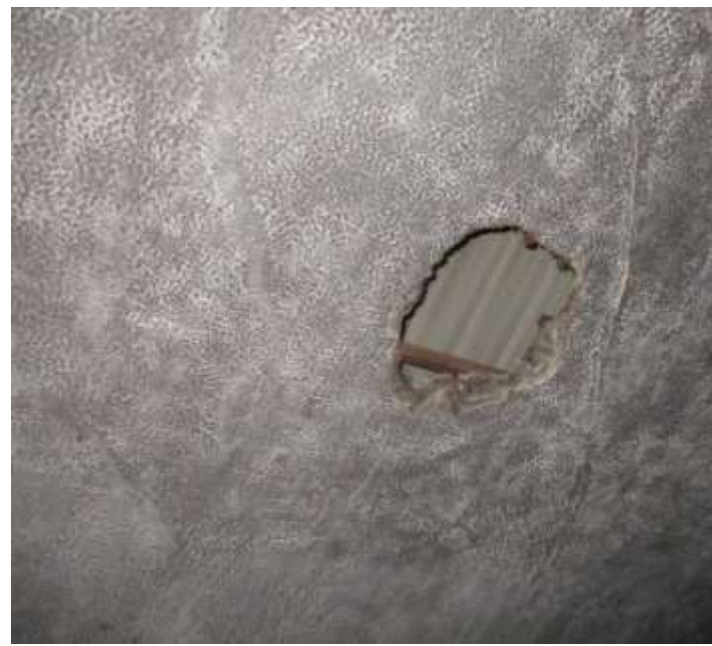
Created By	Eoghan Hickey
Date	3 rd July 2018
Site Details	Old Rialto Cinema Site, South Circular Road, Dublin 8
Client Name	Molaga Capital Ltd.
Survey Type	R/D Asbestos Survey
Site Ref	PE 18-475
Building Ref.	Old Rialto Cinema Site
Location	2 nd Floor & Mezzanine Level
Extent/ Amount	1,000 m ² approx.

MATERIAL ASSESSMENT		PRIORITY ASSESSMENT
Product type	Textured coating	Normal occupant activity	N/A
Extent of damage	Medium damage	Likelihood of disturbance	N/A
Surface treatment	Unsealed	Human exposure potential	N/A
Asbestos type	Chrysotile	Maintenance activity	N/A
Material assessment score: N/A		TOTAL SCORE: N/A	
Priority assessment score: N/A

The textured coating identified the ceiling of the 2nd floor and also on the ceiling of the 2nd floor mezzanine store room contains Chrysotile (white) asbestos fibres. Asbestos containing textured coatings typically contain between 2-5% asbestos fibres

The asbestos containing textured coating should be removed by an asbestos removal contractor and disposed of as asbestos waste before the demolition works commence

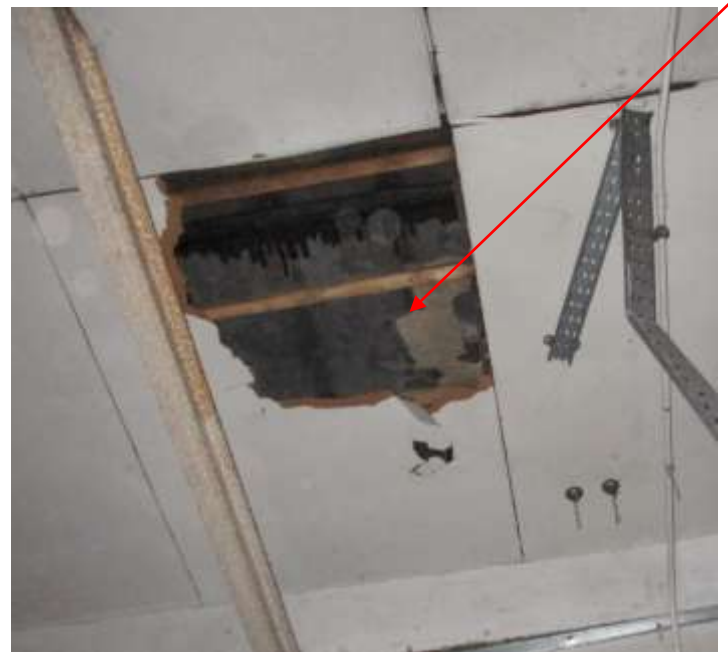
Created By	Eoghan Hickey
Date	3 rd July 2018
Site Details	Old Rialto Cinema Site, South Circular Road, Dublin 8
Client Name	Molaga Capital Ltd.
Survey Type	R/D Asbestos Survey
Site Ref	PE 18-475
Building Ref.	Old Rialto Cinema Site
Location	Under rear pitched roof
Extent/ Amount	80 m ² approx.

MATERIAL ASSESSMENT		PRIORITY ASSESSMENT
Product type	Cement board	Normal occupant activity	N/A
Extent of damage	Medium damage	Likelihood of disturbance	N/A
Surface treatment	Unsealed	Human exposure potential	N/A
Asbestos type	Chrysotile	Maintenance activity	N/A
	Material assessment score: N/A	TOTAL SCORE: N/A	Priority assessment score: N/A

The cement board identified internally on the underside of the 1st floor rear slated roof contains Chrysotile (white) asbestos fibres. Asbestos cement products generally contain between 10 to 15 % asbestos fibres, bound in Portland cement

The asbestos cement board should be removed by an asbestos removal contractor and disposed of as asbestos waste before the demolition works commence

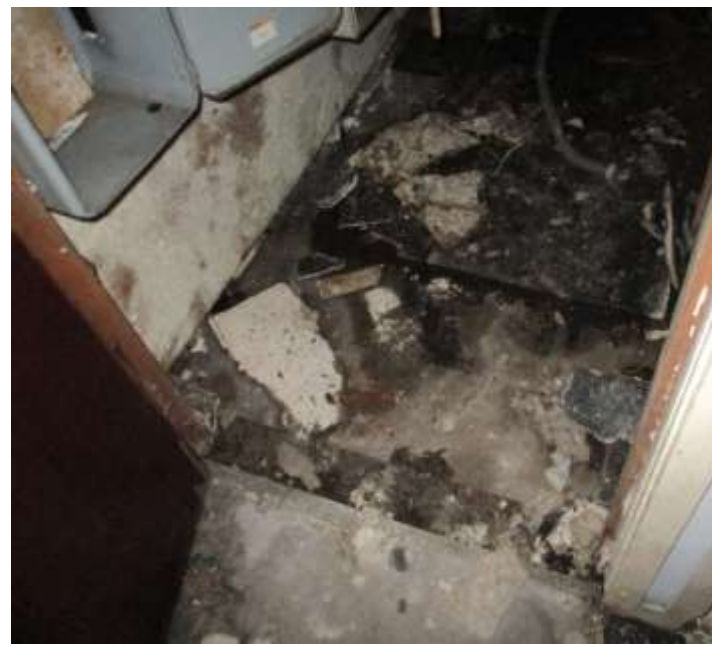
Created By	Eoghan Hickey
Date	3 rd July 2018
Site Details	Old Rialto Cinema Site, South Circular Road, Dublin 8
Client Name	Molaga Capital Ltd.
Survey Type	R/D Asbestos Survey
Site Ref	PE 18-475
Building Ref.	Old Rialto Cinema Site
Location	Ground floor electrical room
Extent/ Amount	10 m ² total approx

MATERIAL ASSESSMENT		PRIORITY ASSESSMENT
Product type	Floor tile & bitumen adhesive	Normal occupant activity	N/A
Extent of damage	Medium damage	Likelihood of disturbance	N/A
Surface treatment	Composite material	Human exposure potential	N/A
Asbestos type	Chrysotile	Maintenance activity	N/A
Material assessment score: N/A		TOTAL SCORE: N/A	
		Priority assessment score: N/A

The floor tile & bitumen adhesive identified in the ground floor electrical room contains Chrysotile (white) asbestos fibres. Bitumen adhesives contain small amounts of asbestos fibres

The floor tiles and bitumen adhesive should be removed by an asbestos removal contractor and disposed of as asbestos waste before the demolition works commence

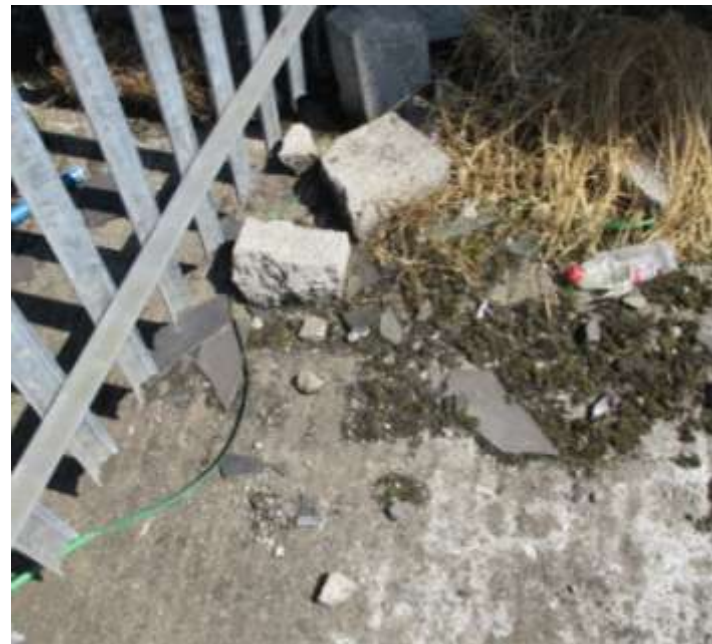
Created By	Eoghan Hickey
Date	3 rd July 2018
Site Details	Old Rialto Cinema Site, South Circular Road, Dublin 8
Client Name	Molaga Capital Ltd.
Survey Type	R/D Asbestos Survey
Site Ref	PE 18-475
Building Ref.	Old Rialto Cinema Site
Location	Rear of site
Extent/ Amount	Not quantified

MATERIAL ASSESSMENT		PRIORITY ASSESSMENT
Product type	Cement debris	Normal occupant activity	N/A
Extent of damage	High damage	Likelihood of disturbance	N/A
Surface treatment	Unsealed	Human exposure potential	N/A
Asbestos type	Chrysotile	Maintenance activity	N/A
	Material assessment score: N/A	TOTAL SCORE: N/A	Priority assessment score: N/A

The cement slate debris identified at the rear of the site contains Chrysotile (white) asbestos fibres. Asbestos cement products generally contain between 10 to 15 % asbestos fibres, bound in Portland cement

The asbestos cement slate debris should be removed by an asbestos removal contractor and disposed of as asbestos waste before the demolition works commence

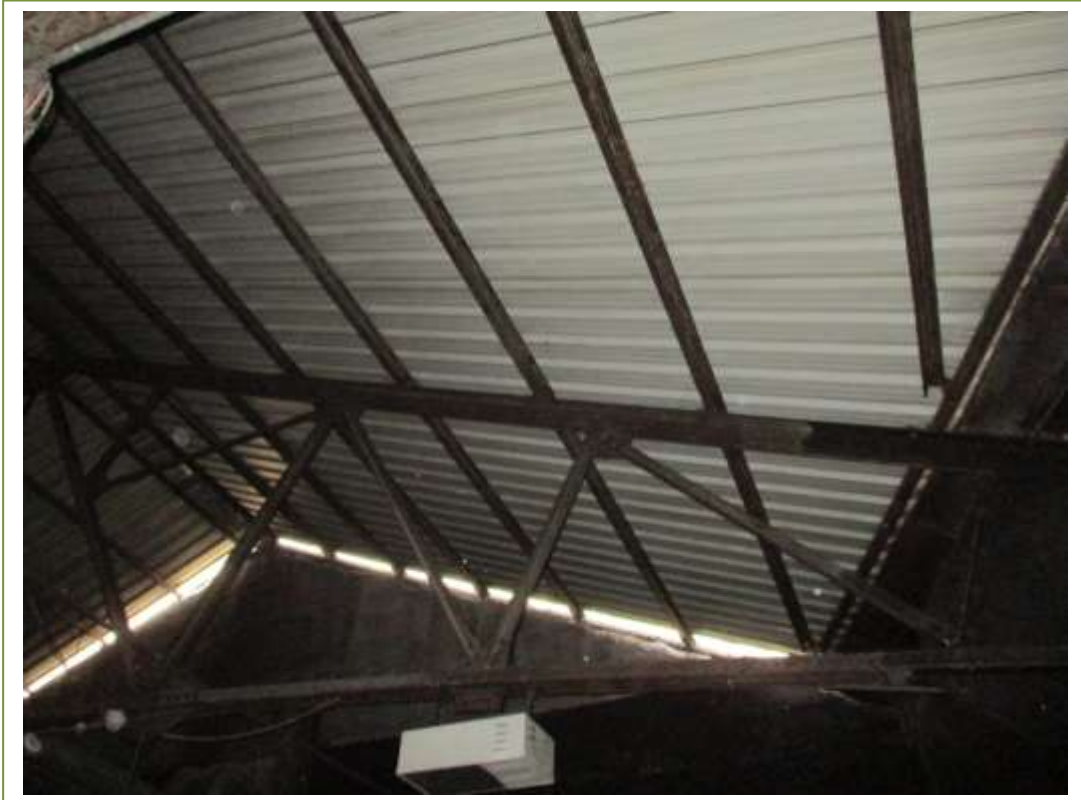
Metal roof cladding. No Asbestos Containing Materials (ACM's) detected

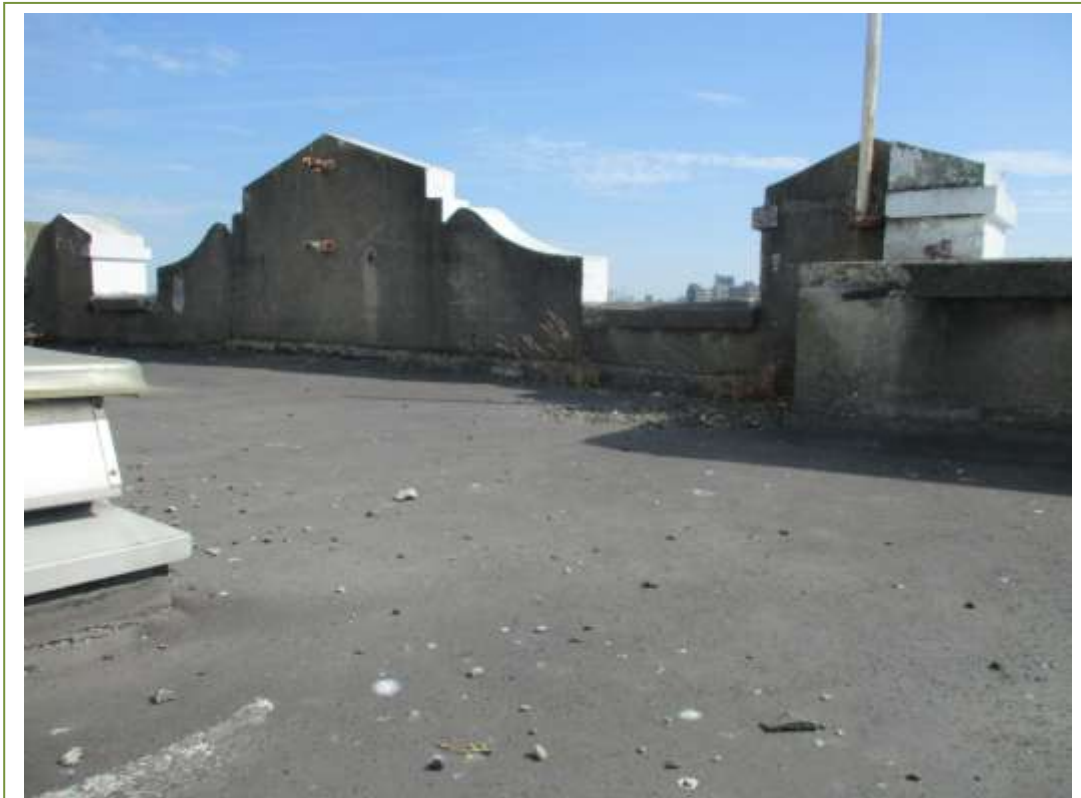
Asphalt on flat roof. No ACM's detected

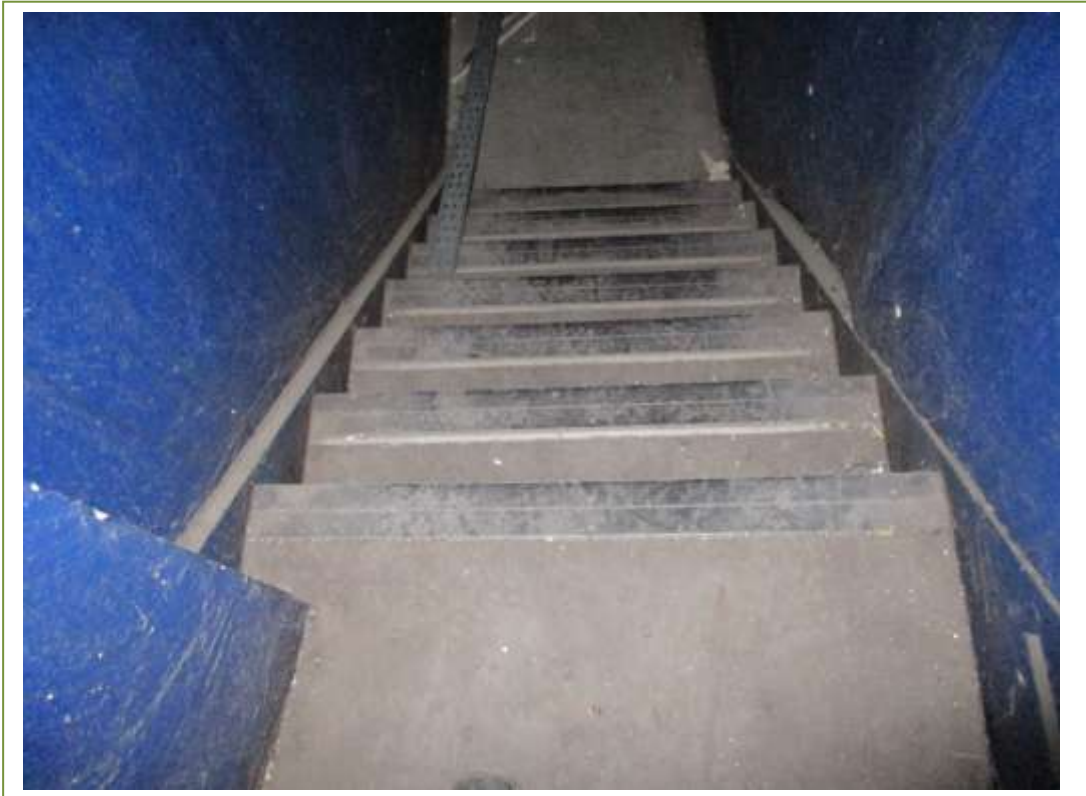
Stair nosing. No ACM's detected

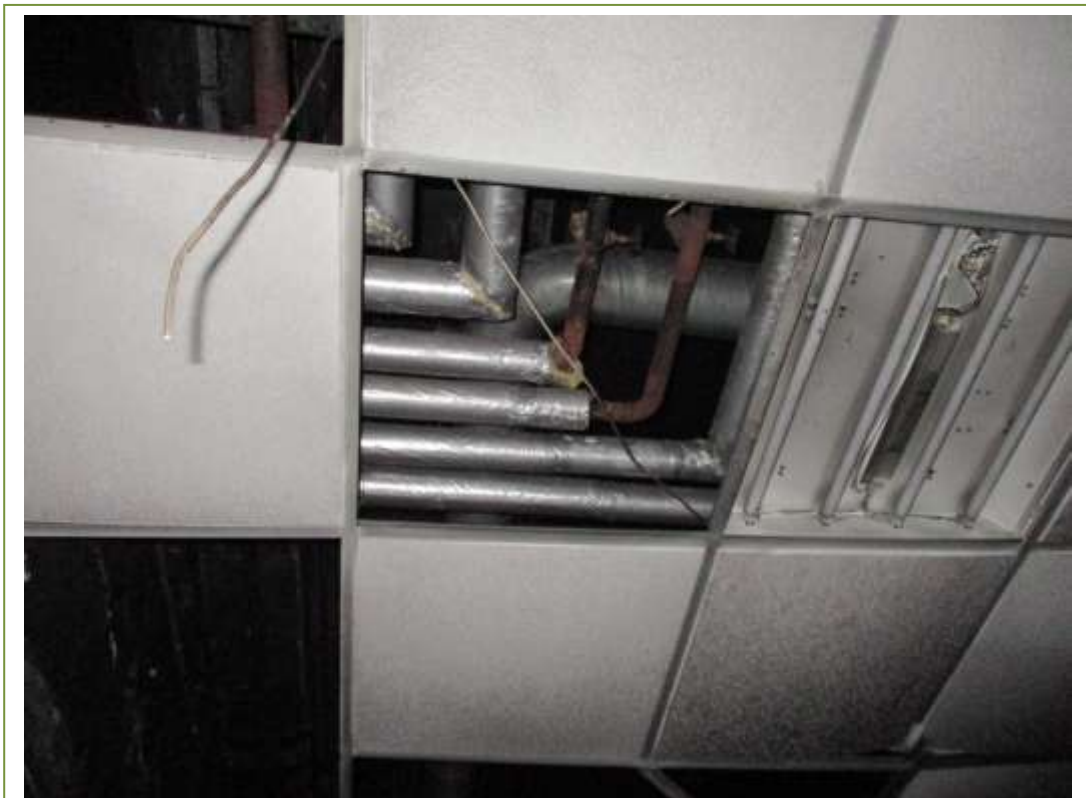
Fiberglass pipework insulation. No ACM's detected

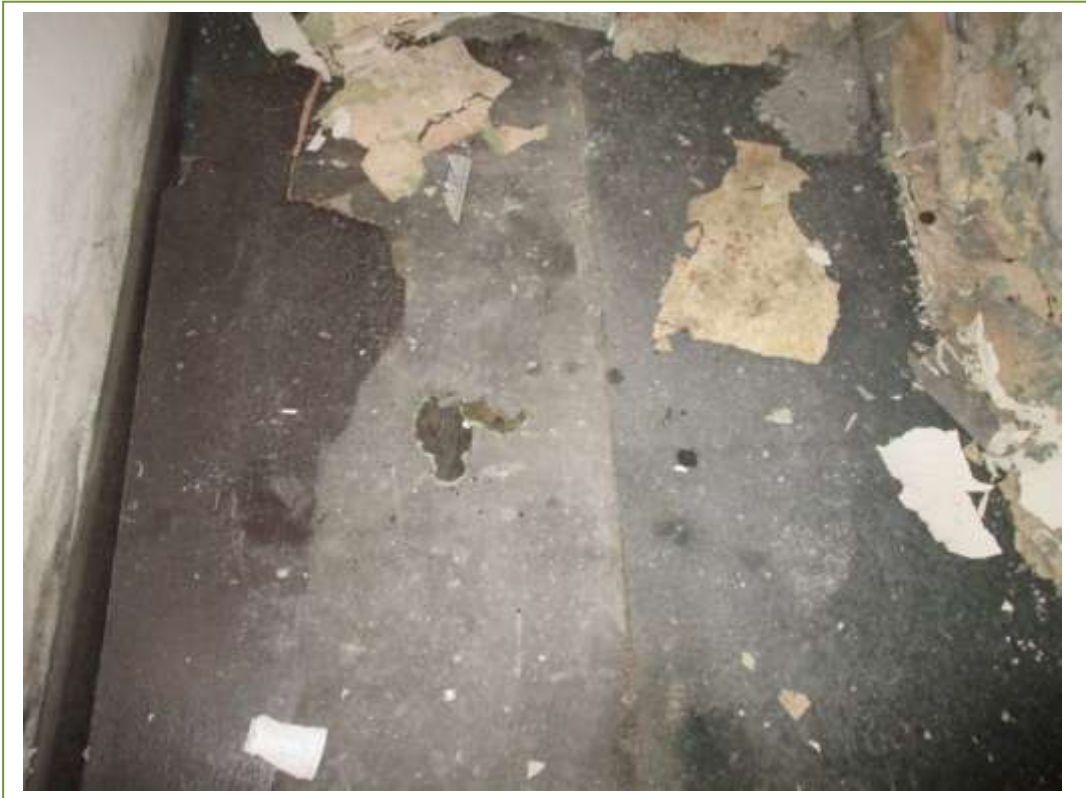
Floor coverings and asphalt in front areas. No ACM's detected

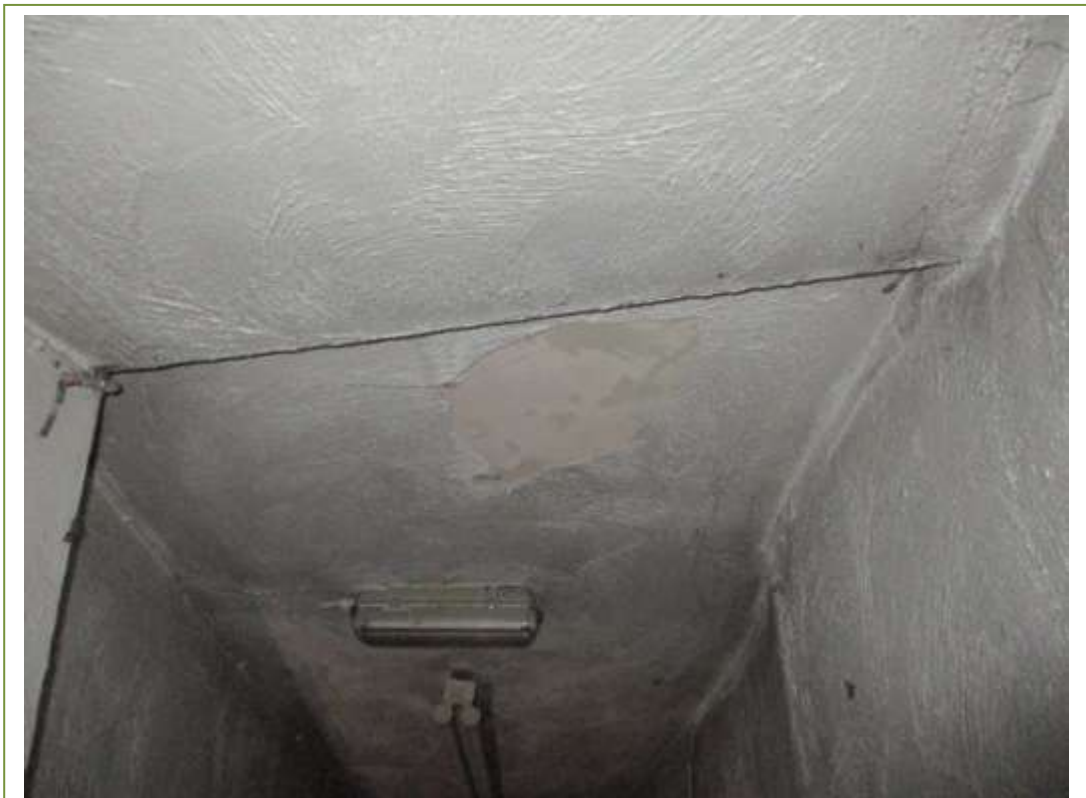
Textured floor coverings on the 1st floor side stairwell ceiling. No ACM's detected

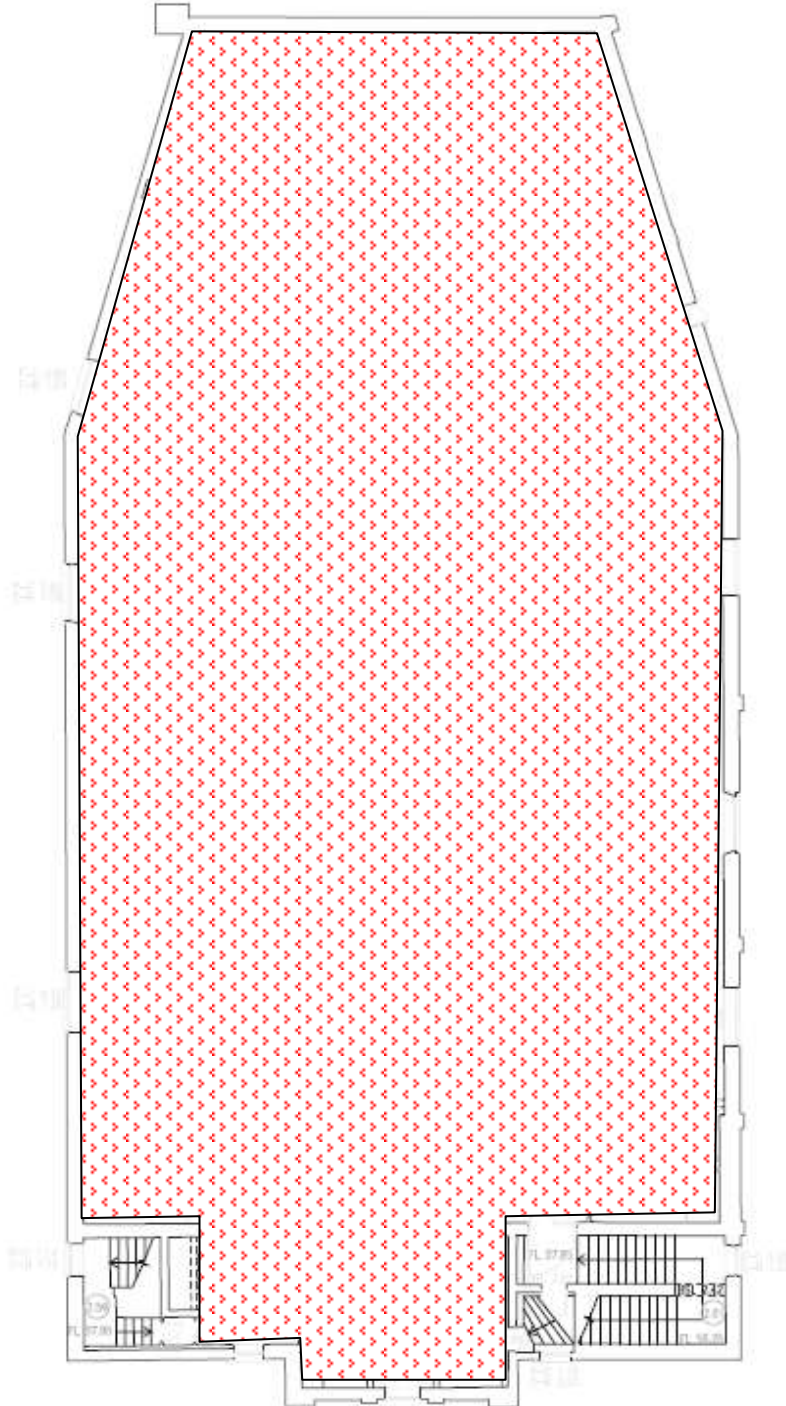
2nd FLOOR PLAN

Areas where asbestos containing textured coating was identified

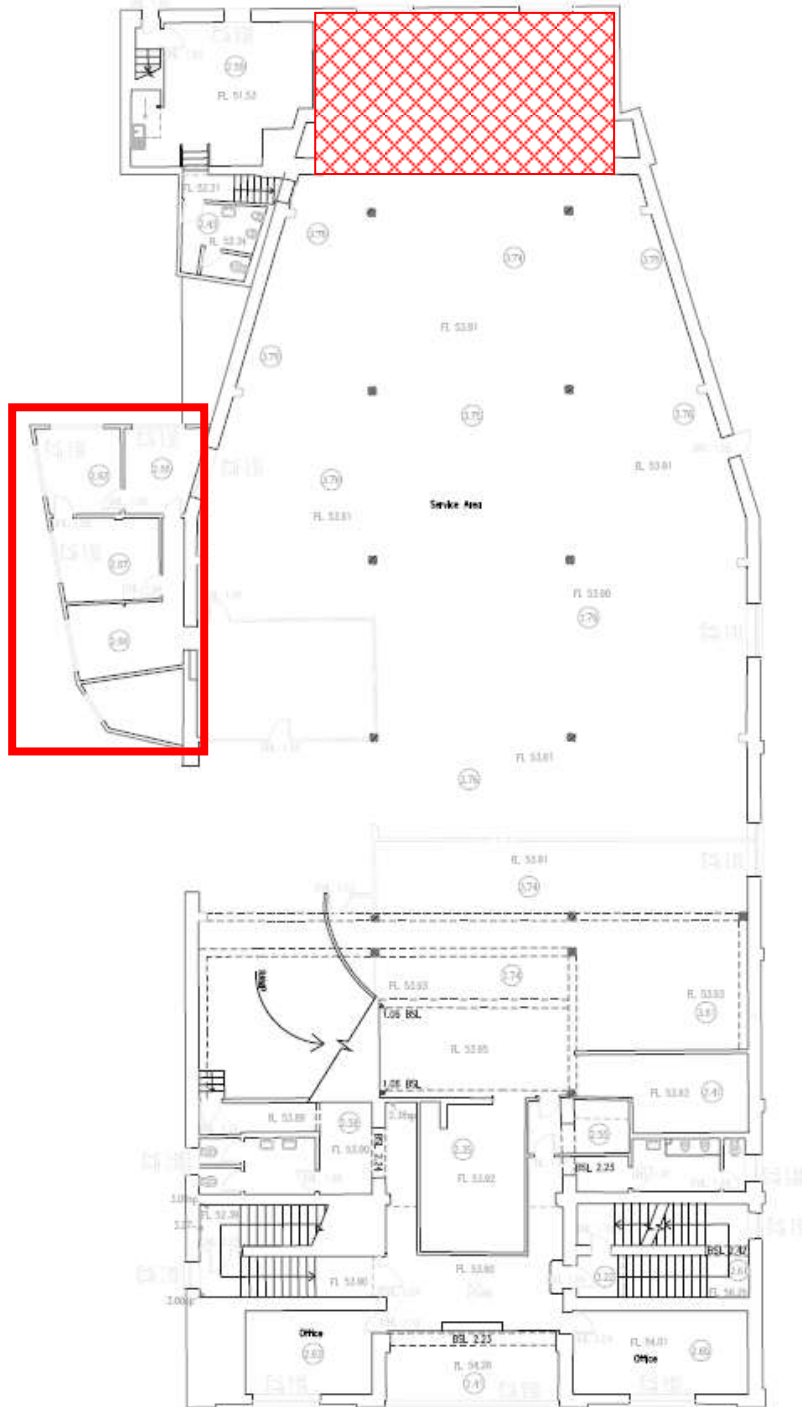
1st FLOOR PLAN

Areas where asbestos cement boards were identified

Areas which were inaccessible

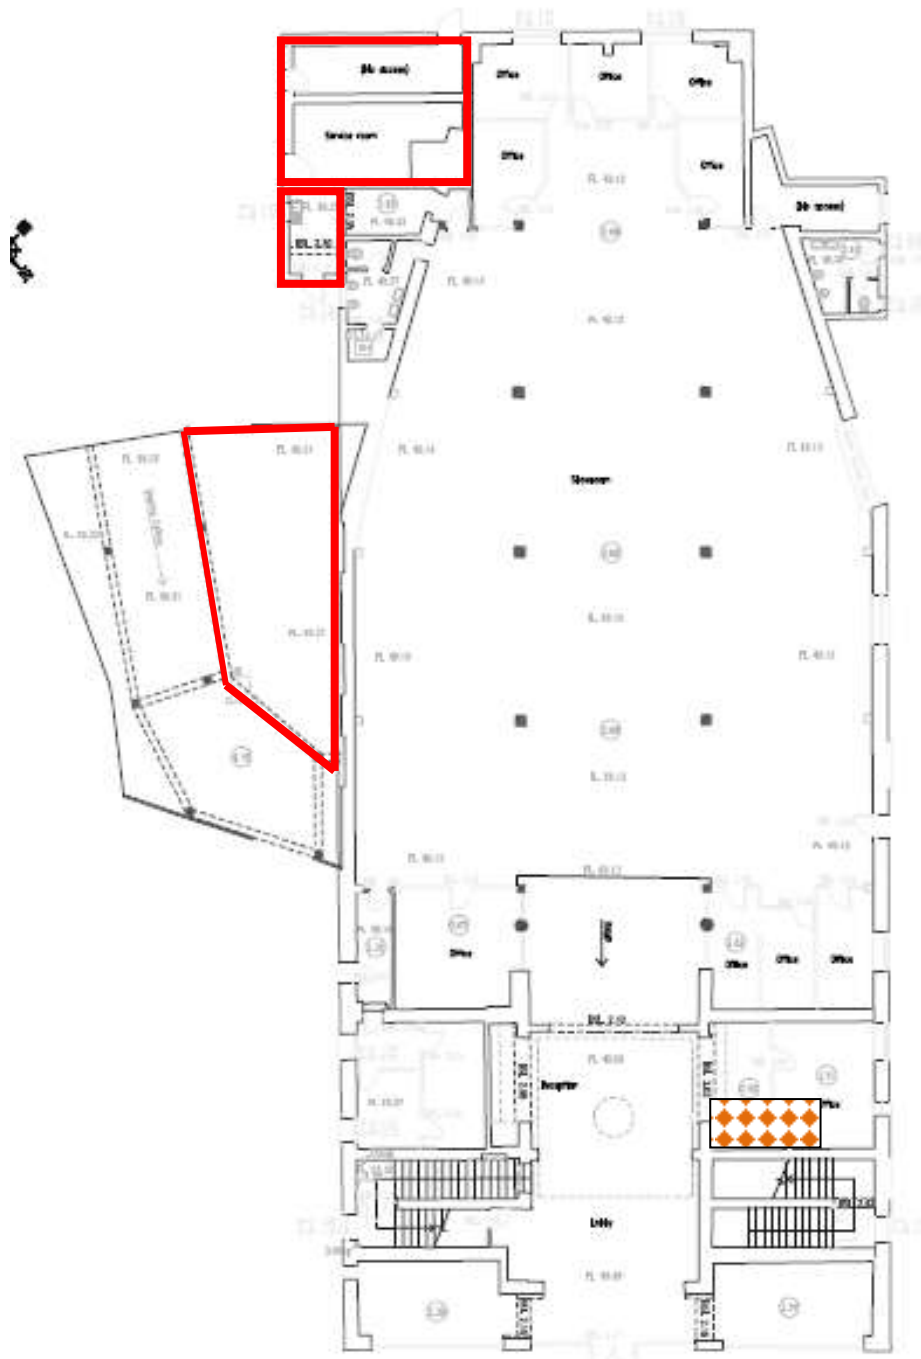
GROUND FLOOR PLAN

Areas which were inaccessible
 	Areas where asbestos containing floor tiles and bitumen adhesive was identified
