**FORMER RIALTO CINEMA
SOUTH CIRCULAR ROAD
DUBLIN 8**

CONSERVATION ASSESSMENT

6th June 2019

**Historic Building Consultants
Old Bawn
Old Connaught
Bray**

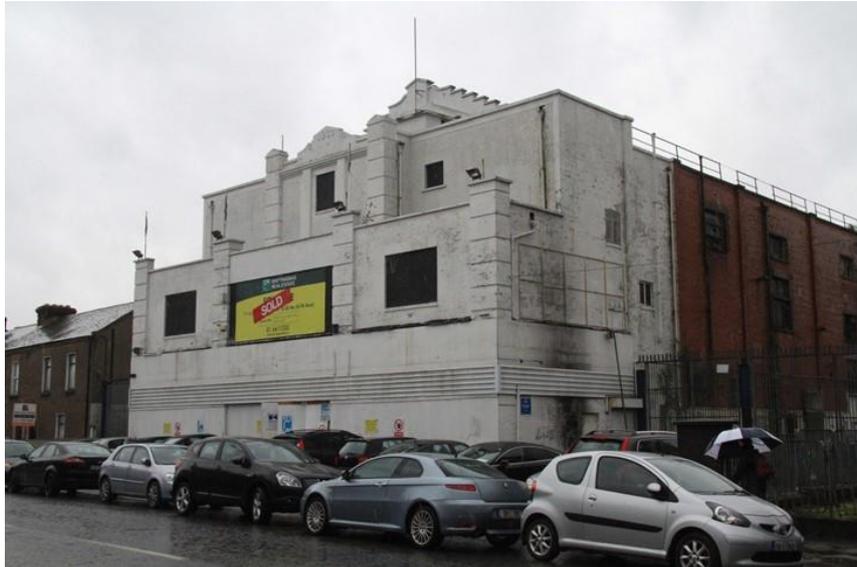
Plate 3: Front of former cinema, seen from north-west

The former Rialto Cinema is a substantial building fronting on to the southern side of South Circular Road to the west of the crossroads at Dolphin's Barn. The building is three-storey at the front and faced with a mix of brick and roughcast render, all of which has been painted. The building is in a modified Art Deco style.

It is proposed to clean the paint off the brickwork on the front of the building so as to return it to its original appearance. The methodology for the removal of the paint will depend on the nature and chemical composition of the paint and it is intended that a specialist masonry cleaning company would be engaged to fulfil this part of the project. It is likely that removal will involve some form of chemical poulticing, but this will not be confirmed until detailed testing is carried out to determine the nature of the paint and hence to select the most effective means of removal. The impact of the system of removal on the surface quality of the brick will be an important element in this decision.

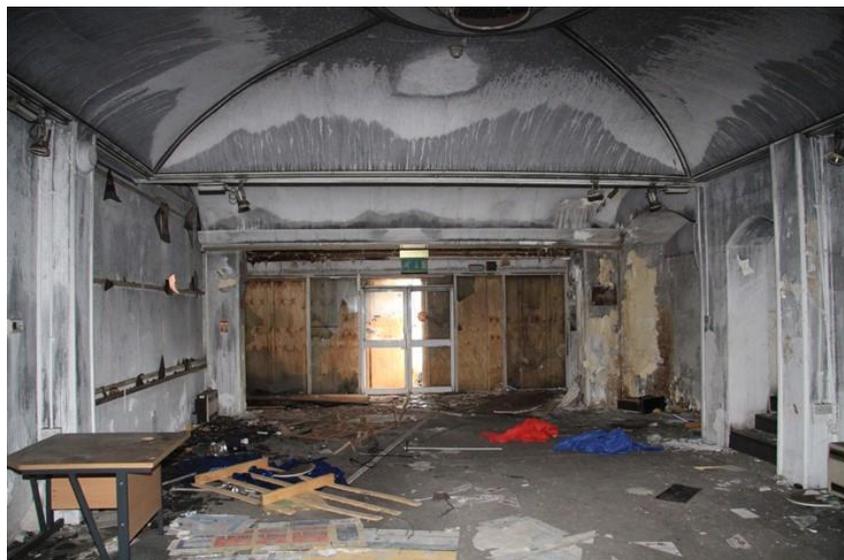
Plate 6: View to front of foyer

The interior of the building is in very poor condition as a result of vandalism. It is also smoke-blackened from a fire, that has impacted part of the ground floor area.

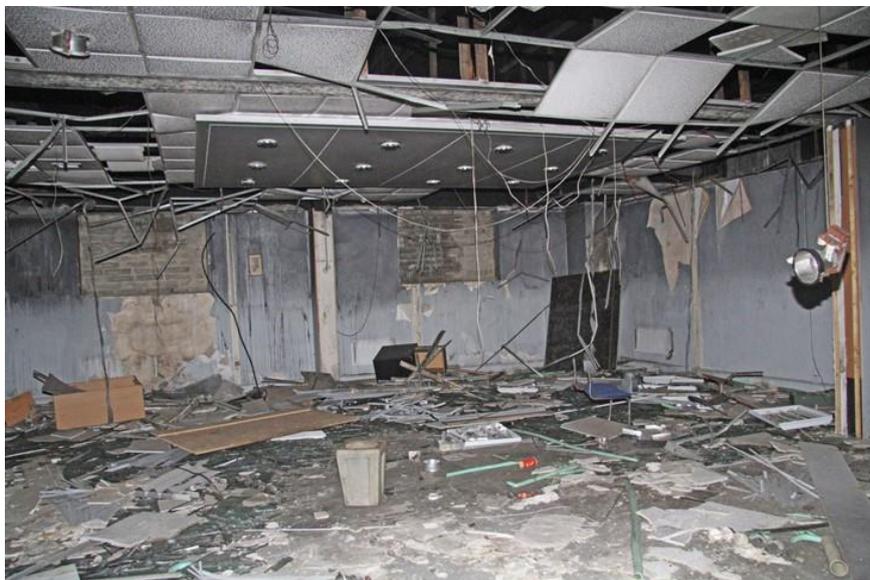
Plate 8: Room leading off foyer

These rooms have been extensively vandalised, with ceilings damaged and partially fallen, wires ripped out and other damage.

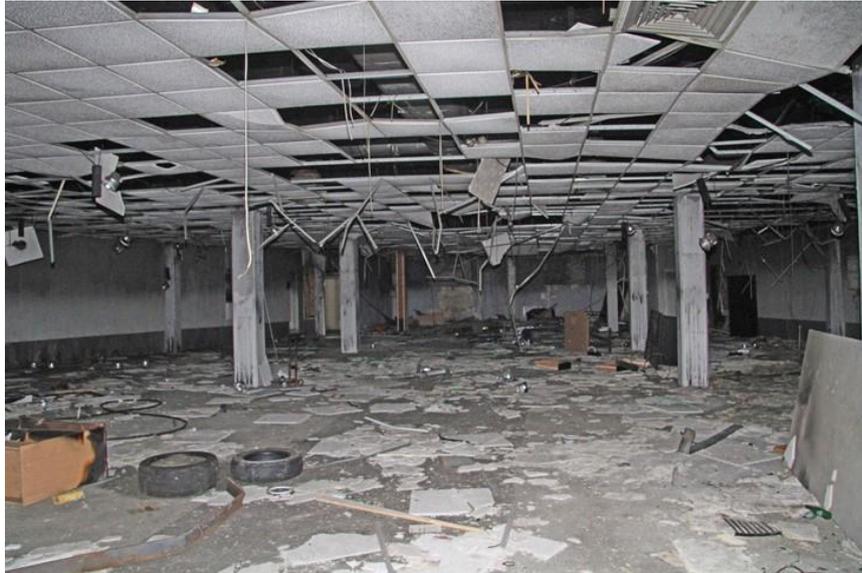
Plate 9: View of auditorium from the foyer

There is nothing left in the former auditorium area to signify its original use. A new floor has been inserted above the ground floor level, supported on mass concrete columns and below which there is a suspended ceiling. The floor in this area is not raked but is level and of mass concrete.

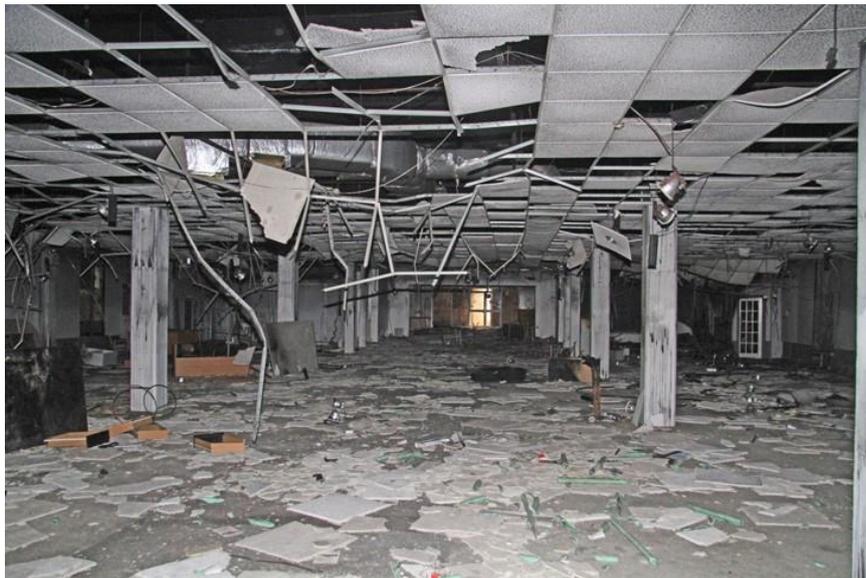
Plate 10: View from former stage area towards foyer

As with the rooms previously described, this area has been vandalised, with the ceilings ripped down and wires ripped out.

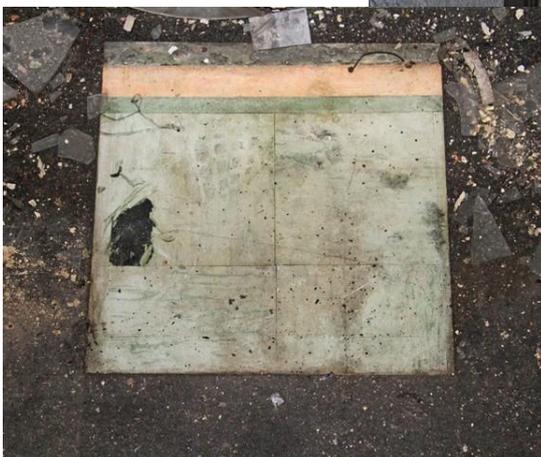
The principal staircase has a covering of carpet tiles, beneath which the original covering may be found – consisting of linoleum tiles in green and yellow, simulating terrazzo.

Plate 13: Linoleum on staircase

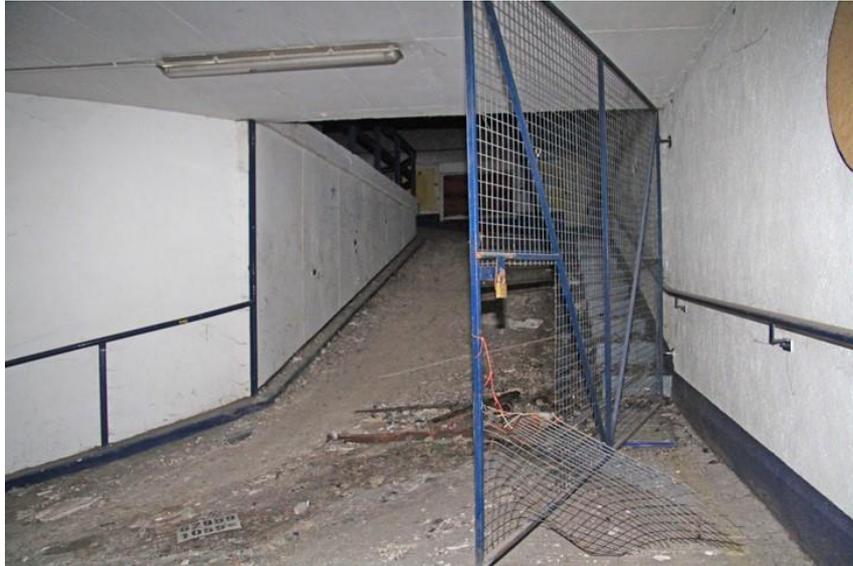
Plate 18: Concrete ramp at first floor

At the rear of the foyer there is a concrete ramp, running up towards the upper floor. This is clearly part of the 1970s conversion for use as a car showroom, at which time the concrete floors were inserted.

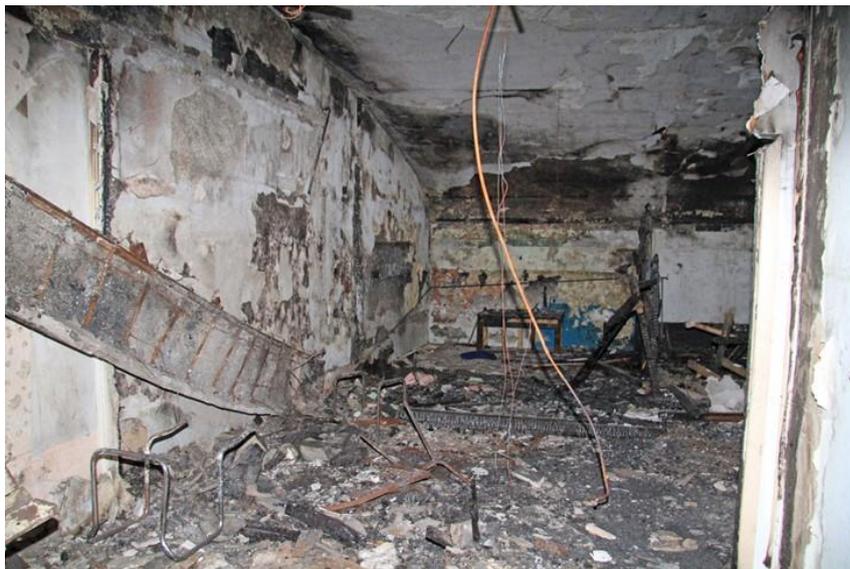
Plate 25: Offices on second floor

This area has been extensively vandalised. There is also a significant amount of water damage arising from leaks in the roof.

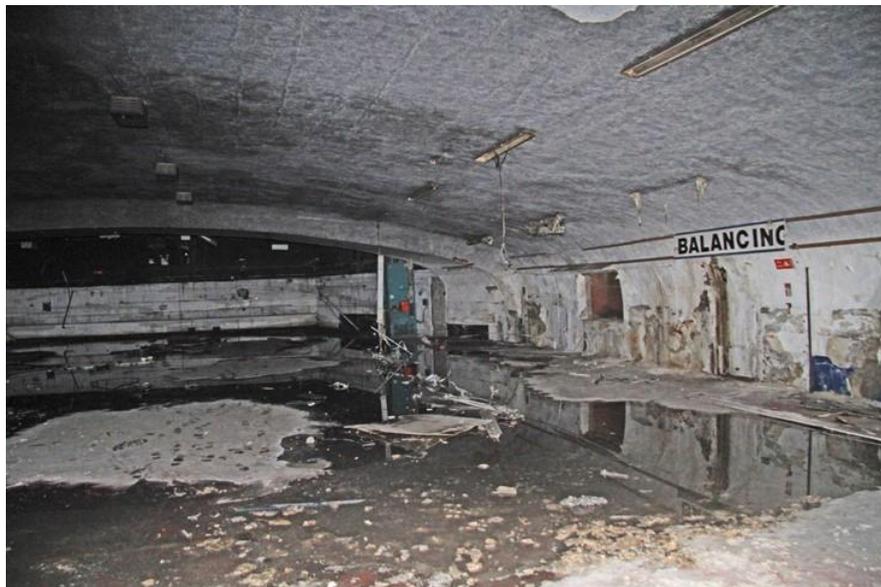
Plate 27: View to rear at second floor level

There is a significant amount of water on the floor, arising from leaks in the roof.
