## Outline Construction & Demolition Management Plan

### Student Accommodation, Rialto Cinema Site, Rialto

Rev. 02

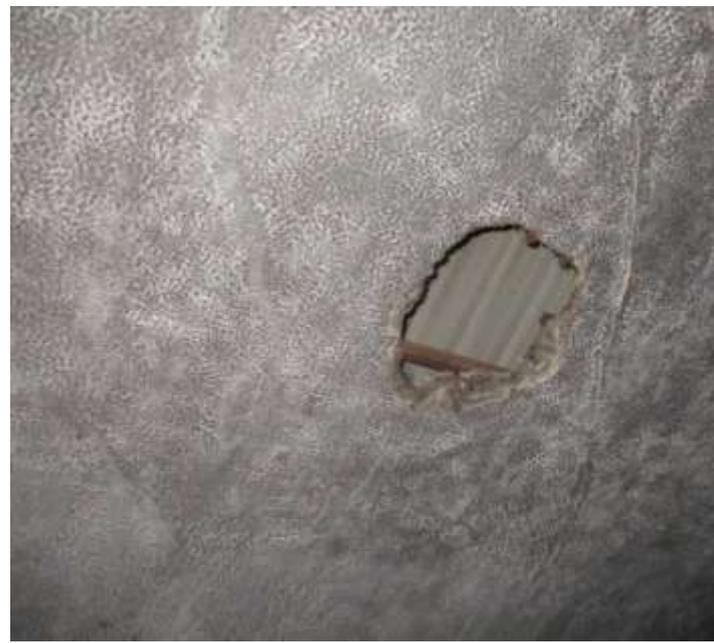
Survey Date	27.6.2018	Sample No.	BS 161591
Survey Company	Phoenix Environmental Safety Ltd.		
Testing Laboratory.	G&L Consultancy Ltd.

Created By	Eoghan Hickey
Date	3 <sup>rd</sup> July 2018
Site Details	Old Rialto Cinema Site, South Circular Road, Dublin 8
Client Name	Molaga Capital Ltd.
Survey Type	R/D Asbestos Survey
Site Ref	PE 18-475
Building Ref.	Old Rialto Cinema Site
Location	2 <sup>nd</sup> Floor & Mezzanine Level
Extent/ Amount	1,000 m <sup>2</sup> approx.

MATERIAL ASSESSMENT		PRIORITY ASSESSMENT
Product type	Textured coating	Normal occupant activity	N/A
Extent of damage	Medium damage	Likelihood of disturbance	N/A
Surface treatment	Unsealed	Human exposure potential	N/A
Asbestos type	Chrysotile	Maintenance activity	N/A
	Material assessment score: N/A	TOTAL SCORE: N/A	Priority assessment score: N/A

All asbestos removal work must be carried out in accordance with S.I. No. 386 of 2006 Safety, Health and Welfare at Work (Exposure to Asbestos) Regulations 2006-2010

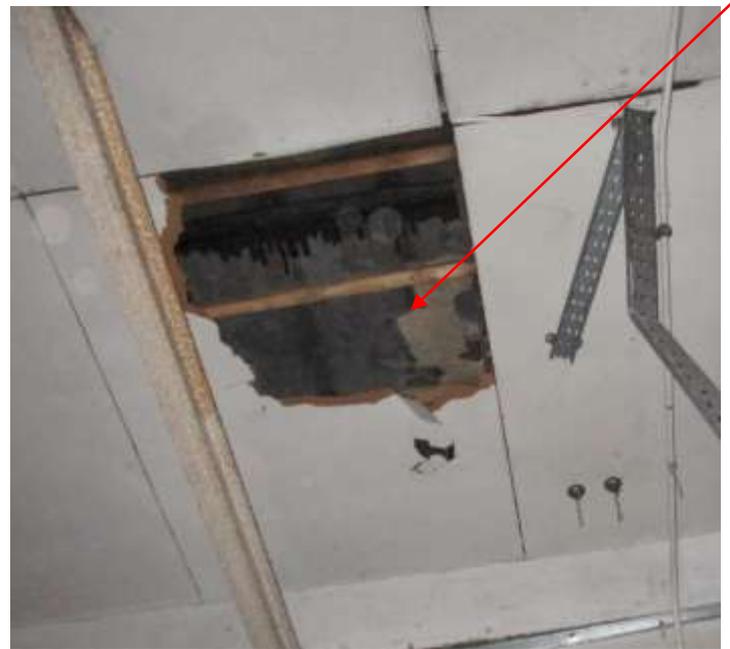
Survey Date	27.6.2018	Sample No.	BS 161596
Survey Company	Phoenix Environmental Safety Ltd.		
Testing Laboratory.	G&L Consultancy Ltd.

Created By	Eoghan Hickey
Date	3 <sup>rd</sup> July 2018
Site Details	Old Rialto Cinema Site, South Circular Road, Dublin 8
Client Name	Molaga Capital Ltd.
Survey Type	R/D Asbestos Survey
Site Ref	PE 18-475
Building Ref.	Old Rialto Cinema Site
Location	Under rear pitched roof
Extent/ Amount	80 m <sup>2</sup> approx.

MATERIAL ASSESSMENT		PRIORITY ASSESSMENT
Product type	Cement board	Normal occupant activity	N/A
Extent of damage	Medium damage	Likelihood of disturbance	N/A
Surface treatment	Unsealed	Human exposure potential	N/A
Asbestos type	Chrysotile	Maintenance activity	N/A
Material assessment score: N/A		TOTAL SCORE: N/A	
Priority assessment score: N/A

All asbestos removal work must be carried out in accordance with S.I. No. 386 of 2006 Safety, Health and Welfare at Work (Exposure to Asbestos) Regulations 2006-2010

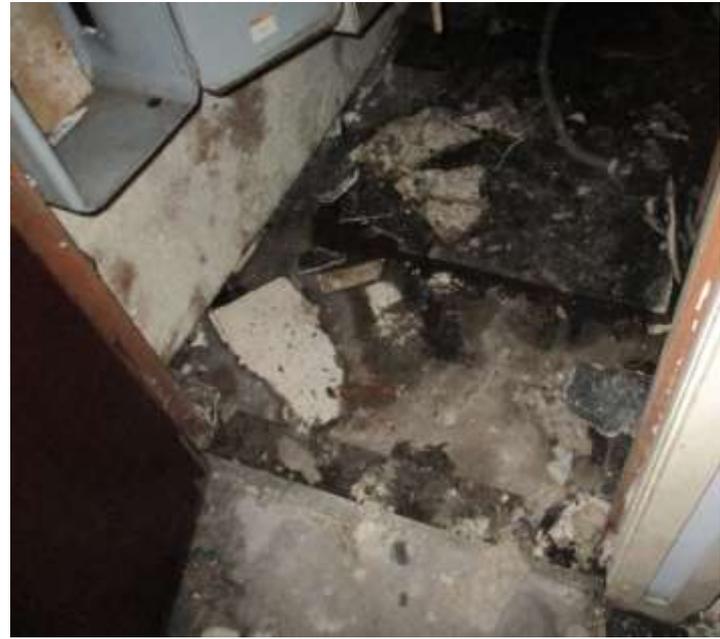
Survey Date	27.6.2018	Sample No.	BS 161600
Survey Company	Phoenix Environmental Safety Ltd.		
Testing Laboratory.	G&L Consultancy Ltd.

Created By	Eoghan Hickey
Date	3 <sup>rd</sup> July 2018
Site Details	Old Rialto Cinema Site, South Circular Road, Dublin 8
Client Name	Molaga Capital Ltd.
Survey Type	R/D Asbestos Survey
Site Ref	PE 18-475
Building Ref.	Old Rialto Cinema Site
Location	Ground floor electrical room
Extent/ Amount	10 m <sup>2</sup> total approx

MATERIAL ASSESSMENT		PRIORITY ASSESSMENT
Product type	Floor tile & bitumen adhesive	Normal occupant activity	N/A
Extent of damage	Medium damage	Likelihood of disturbance	N/A
Surface treatment	Composite material	Human exposure potential	N/A
Asbestos type	Chrysotile	Maintenance activity	N/A
	Material assessment score: N/A	TOTAL SCORE: N/A	Priority assessment score: N/A

All asbestos removal work must be carried out in accordance with S.I. No. 386 of 2006 Safety, Health and Welfare at Work (Exposure to Asbestos) Regulations 2006-2010

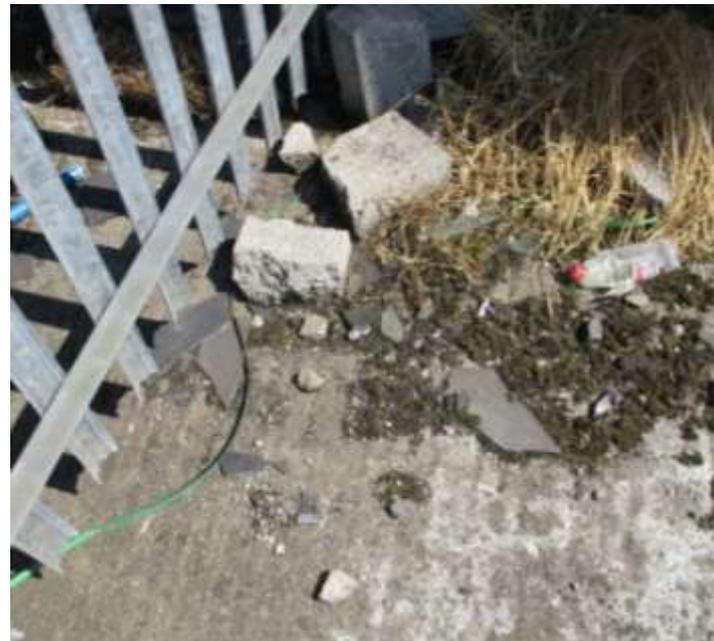
Survey Date	27.6.2018	Sample No.	BS 161601
Survey Company	Phoenix Environmental Safety Ltd.		
Testing Laboratory	G&L Consultancy Ltd.

Created By	Eoghan Hickey
Date	3 <sup>rd</sup> July 2018
Site Details	Old Rialto Cinema Site, South Circular Road, Dublin 8
Client Name	Molaga Capital Ltd.
Survey Type	R/D Asbestos Survey
Site Ref	PE 18-475
Building Ref.	Old Rialto Cinema Site
Location	Rear of site
Extent/ Amount	Not quantified

MATERIAL ASSESSMENT		PRIORITY ASSESSMENT
Product type	Cement debris	Normal occupant activity	N/A
Extent of damage	High damage	Likelihood of disturbance	N/A
Surface treatment	Unsealed	Human exposure potential	N/A
Asbestos type	Chrysotile	Maintenance activity	N/A
	Material assessment score: N/A	TOTAL SCORE: N/A	Priority assessment score: N/A

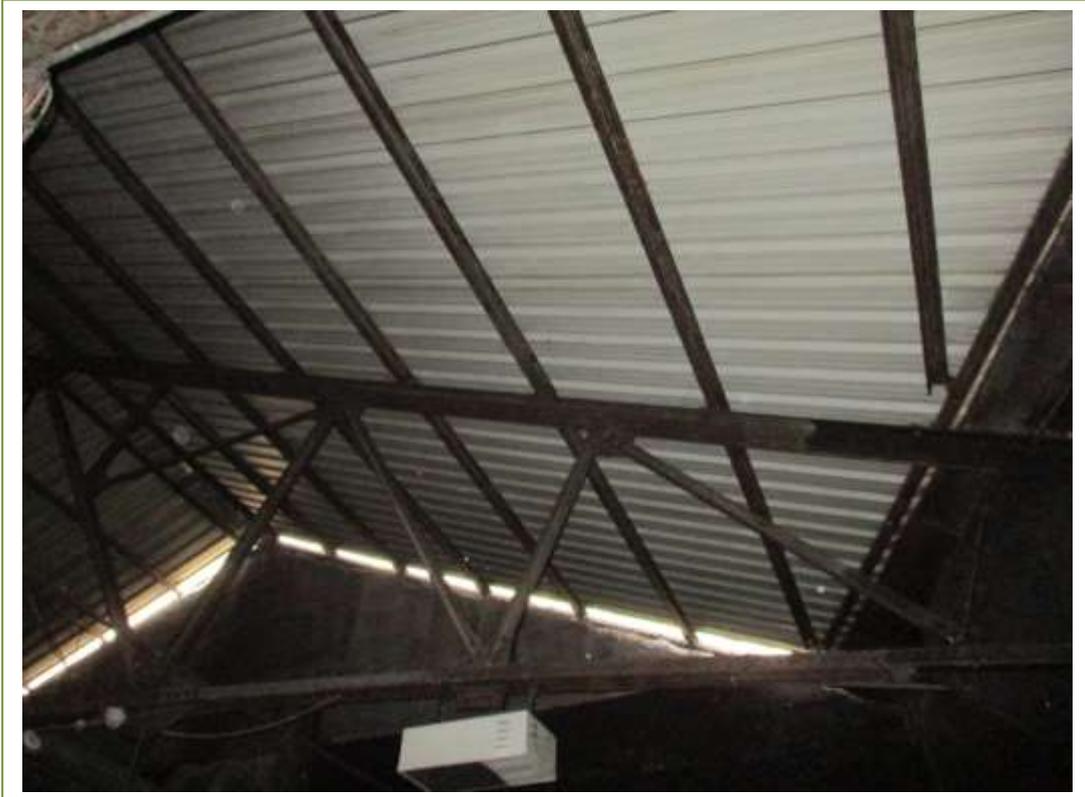
Metal roof cladding. No Asbestos Containing Materials (ACM's) detected

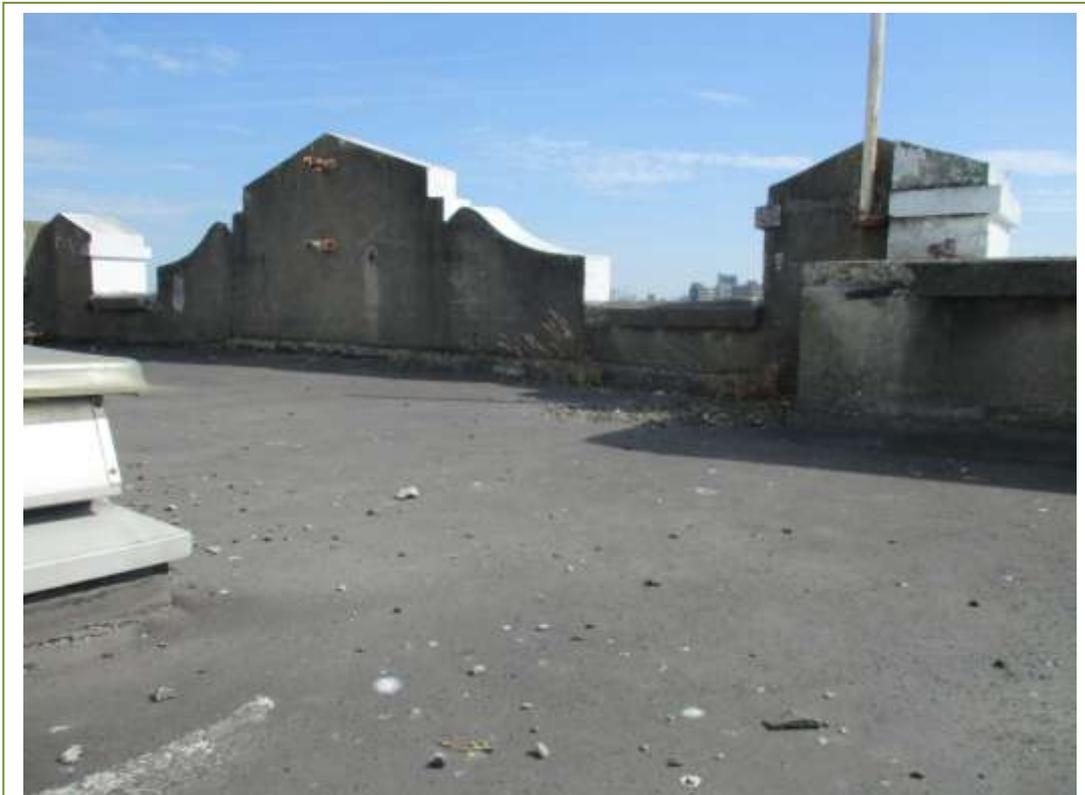
Asphalt on flat roof. No ACM's detected

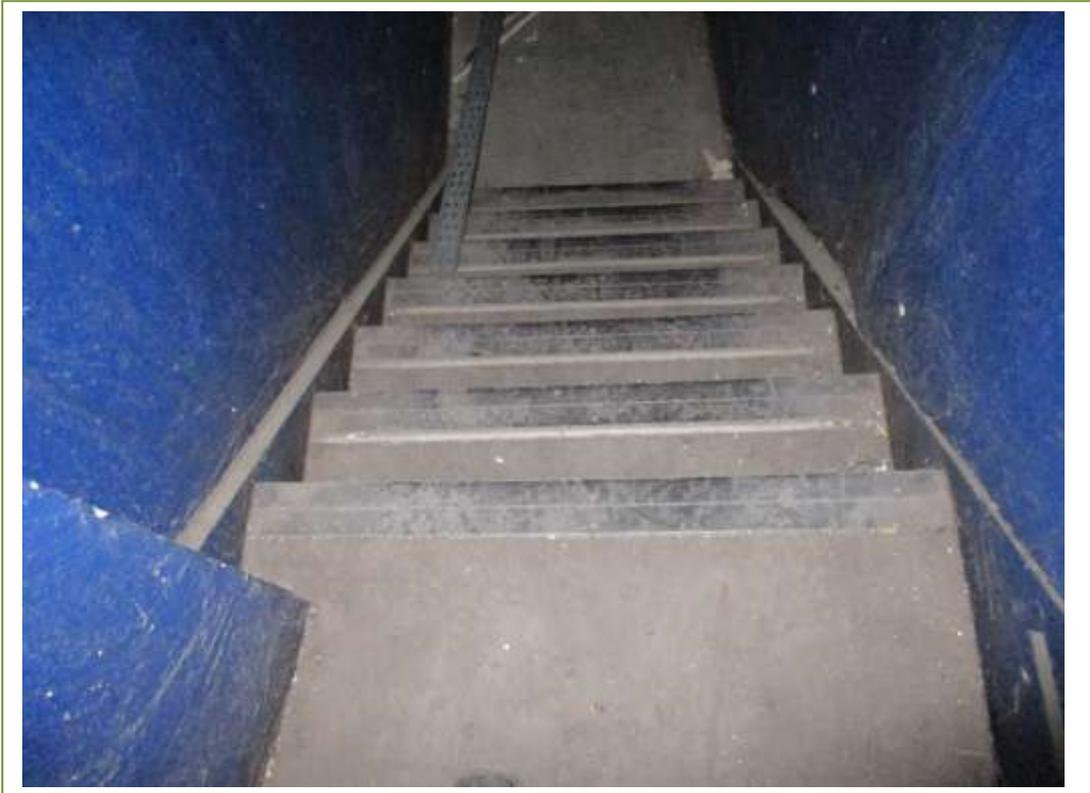
Stair nosing. No ACM's detected

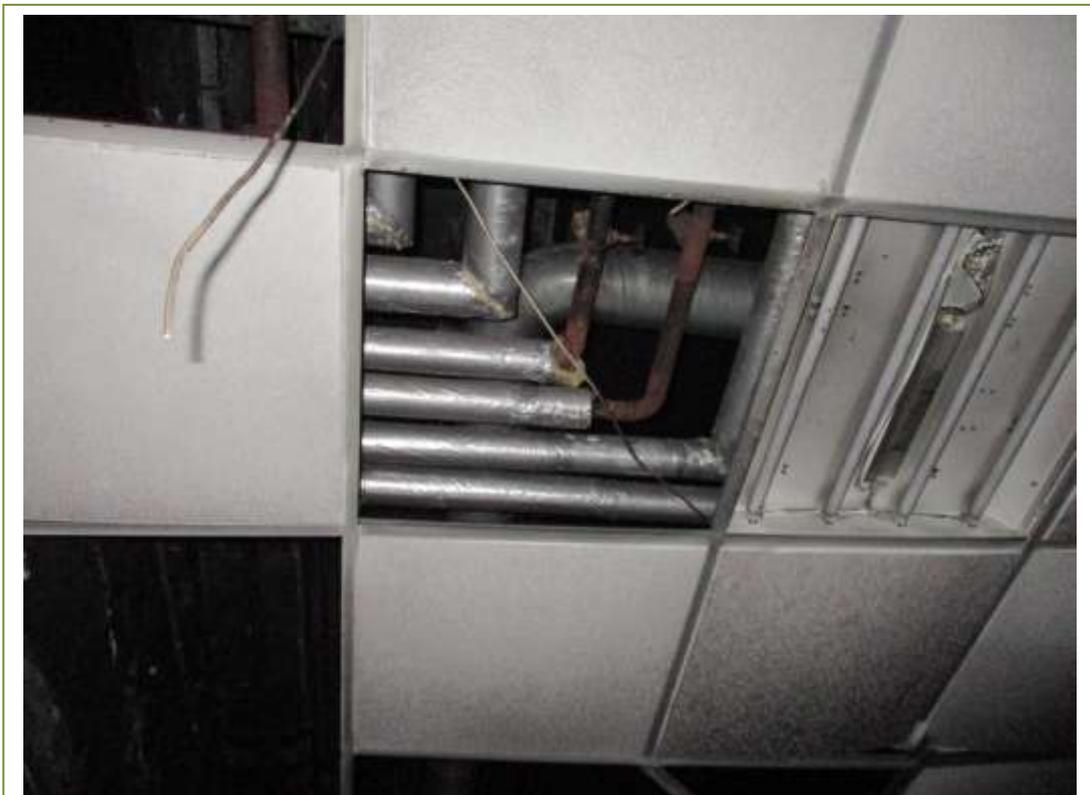
Fiberglass pipework insulation. No ACM's detected

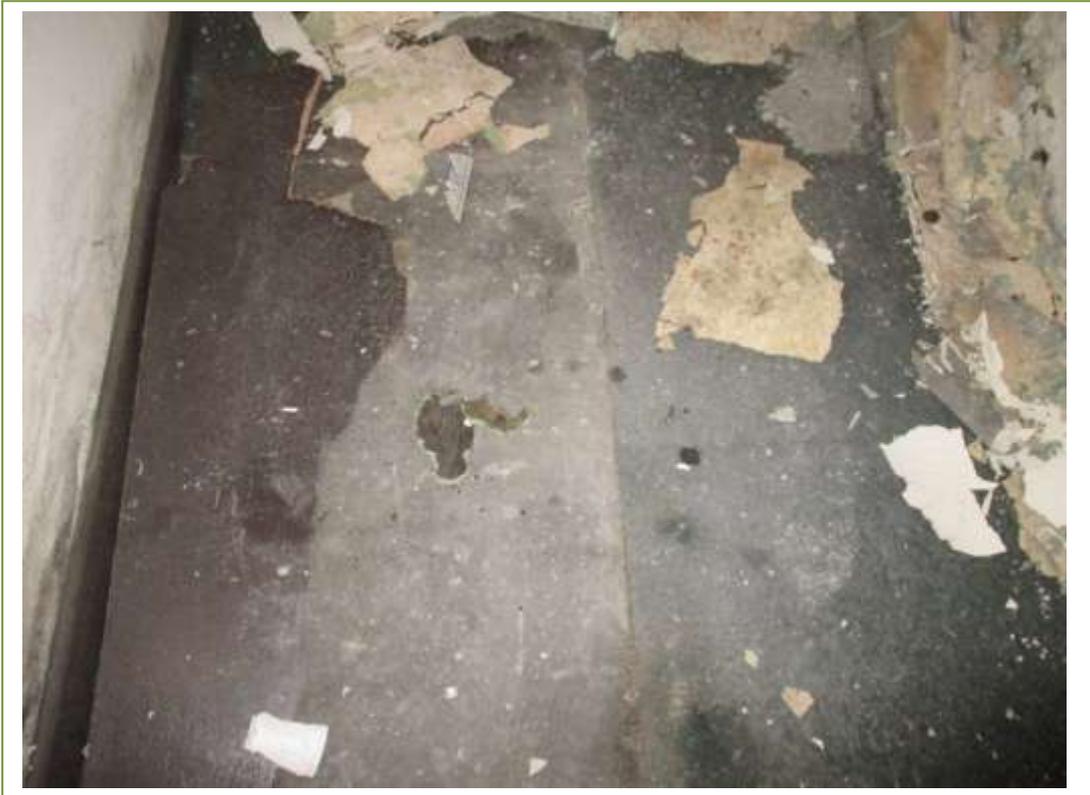
Floor coverings and asphalt in front areas. No ACM's detected

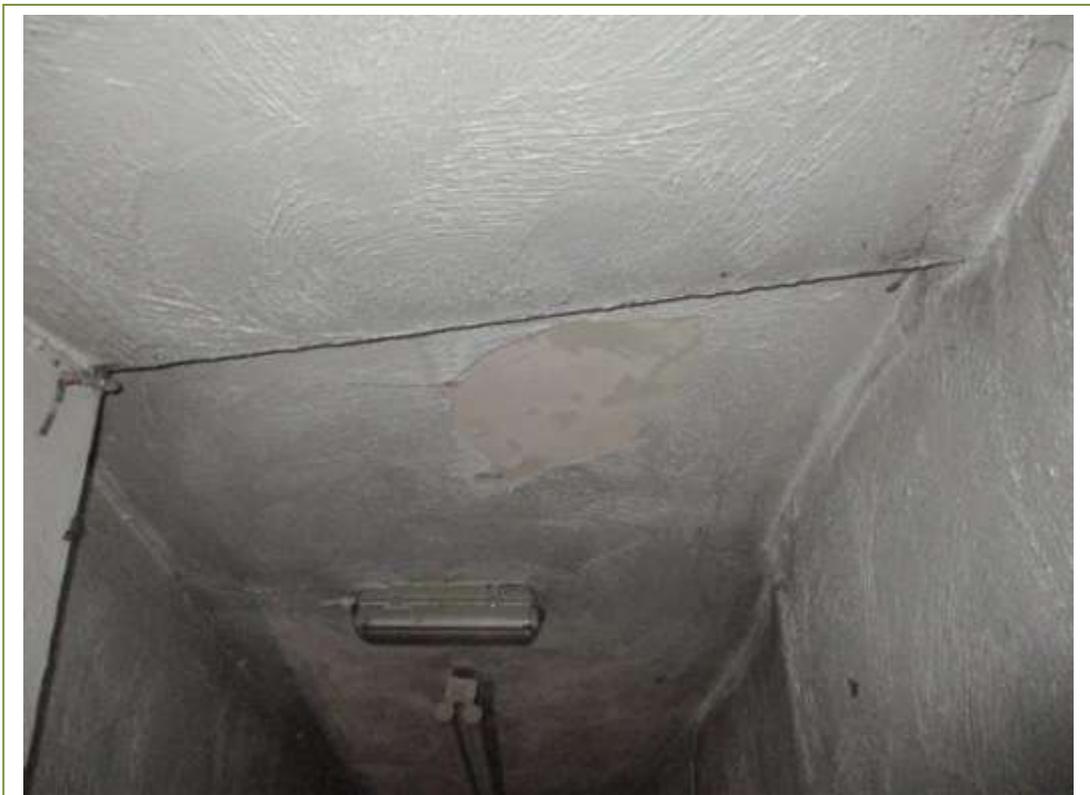
Textured floor coverings on the 1<sup>st</sup> floor side stairwell ceiling. No ACM's detected

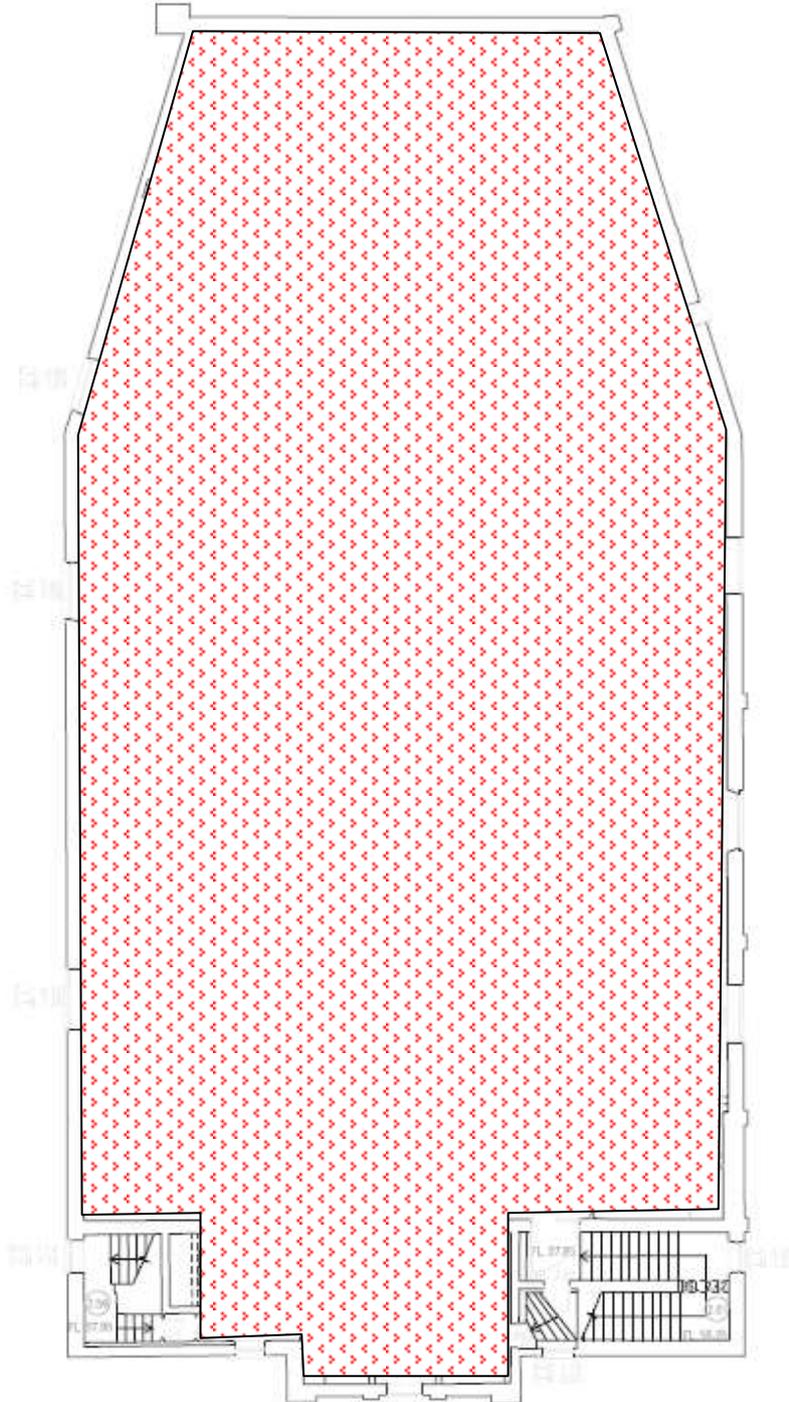
### 2<sup>nd</sup> FLOOR PLAN

Areas where asbestos containing textured coating was identified
