**FORMER RIALTO CINEMA
SOUTH CIRCULAR ROAD
DUBLIN 8**

CONSERVATION ASSESSMENT

6th June 2019

**Historic Building Consultants
Old Bawn
Old Connaught
Bray**

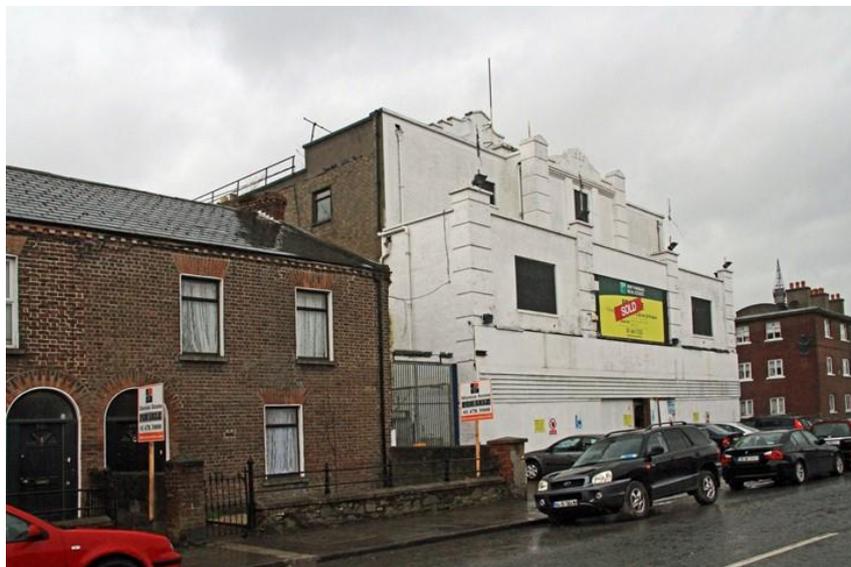
Plate 4: Front of former cinema, seen from north-east

The ground floor and first floor are set back slightly from the street, aligning with the adjacent residential properties. The second floor is set back from the rest of the frontage. The western side of the building is faced with red machine-made brick, while the eastern elevation, originally less visible, is faced with a cheaper yellow Dolphin's Barn brick.

It is proposed to clean the paint off the brickwork on the front of the building so as to return it to its original appearance. The methodology for the removal of the paint will depend on the nature and chemical composition of the paint and it is intended that a specialist masonry cleaning company would be engaged to fulfil this part of the project. It is likely that removal will involve some form of chemical poulticing, but this will not be confirmed until detailed testing is carried out to determine the nature of the paint and hence to select the most effective means of removal. The impact of the system of removal on the surface quality of the brick will be an important element in this decision.

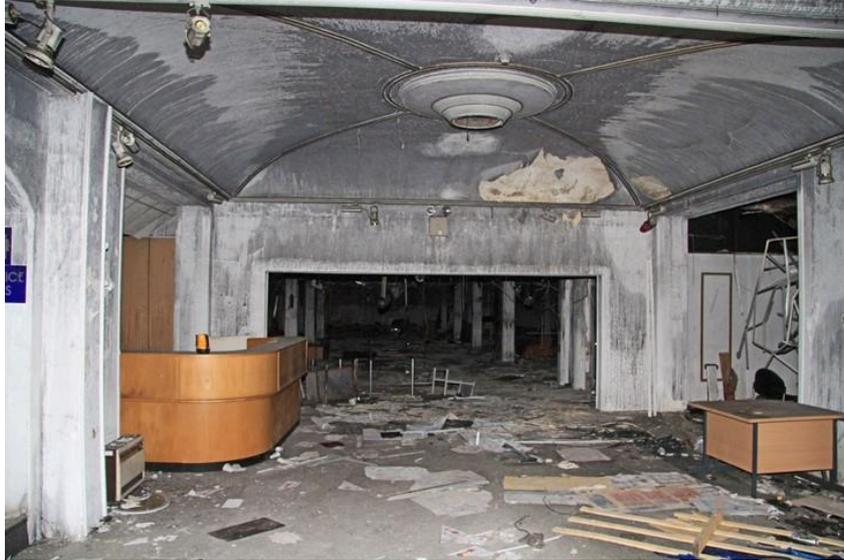
Plate 5: View into cinema from entrance

The entrance to the cinema is in the centre of the front façade and leads in to a foyer above which there is a coved ceiling with central lantern. On either side of this foyer were shops, with shopfronts onto the street and with separate access from the foyer. To the rear of the shops a staircase leads up to the left. There is a second staircase to the right, enclosed behind a door. Beyond the staircases a desk of 1970s vintage sits on the left-hand side, while on the right a room leads off the foyer. At the rear a large opening leads into the auditorium.

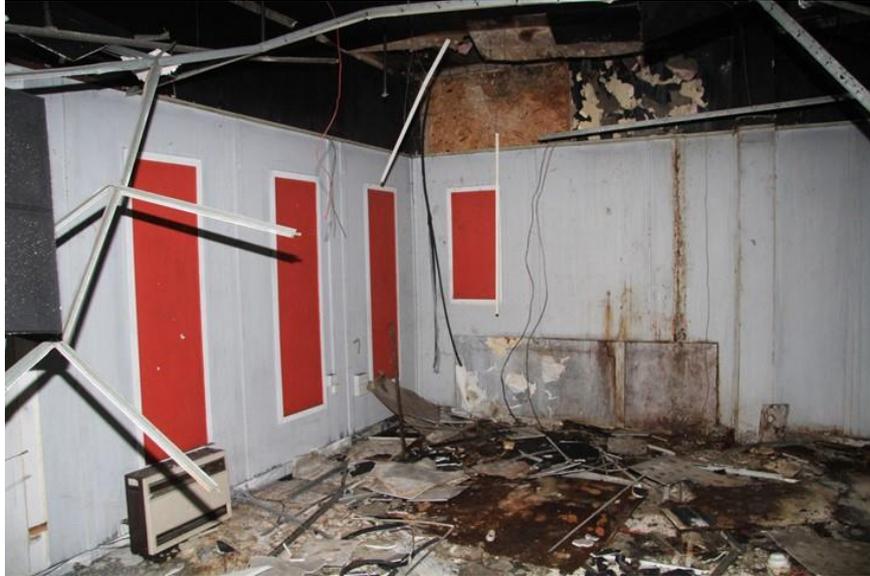
Plate 7: Room leading off foyer

Each of the several spaces that leads off the main foyer at ground level is relatively plain and for the most part these rooms or spaces have been fitted out in the later twentieth century as part of the conversion to motor showrooms. The fit-out includes suspended ceilings and, in some places, wall panels. These areas include the two shops, the interiors of which were also plain and devoid of particular architectural interest.

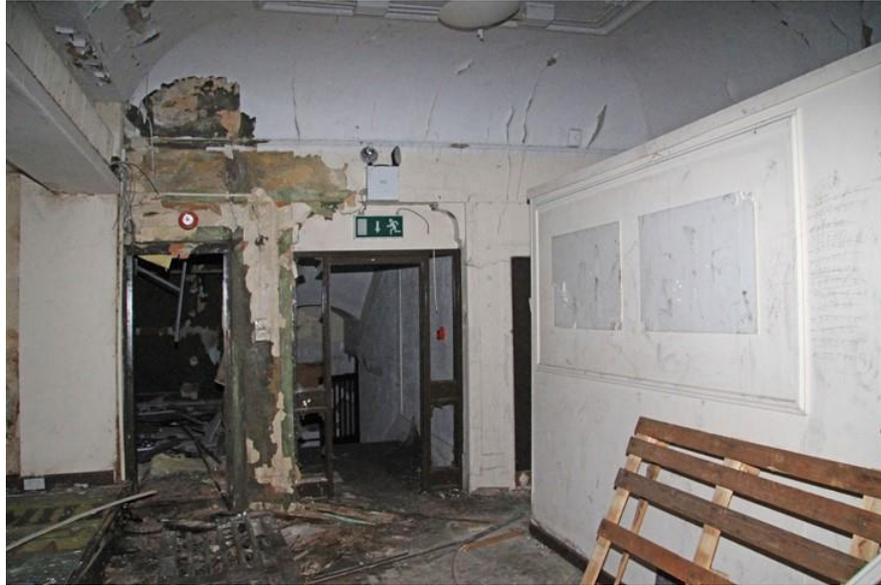
Plate 14: First floor lobby

At first floor level there is a lobby with a coved ceiling. Part of this has been partitioned off to provide office space for the car dealer, though the partitioning is low, and the full extent of the ceiling is visible. The lobby extends beneath a beam to a window in the front elevation, now boarded up. Passageways on either side of the partitioning lead to the site of the original balcony.

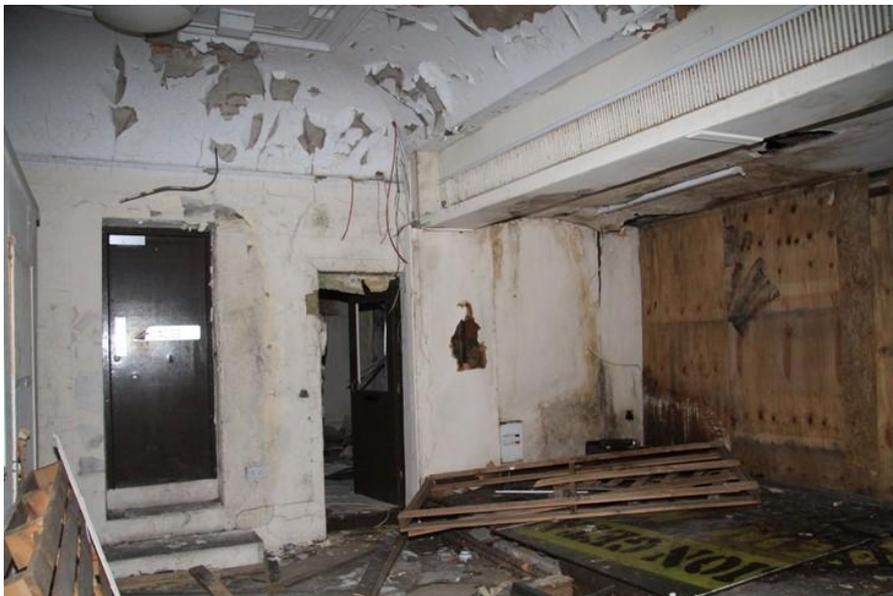
Plate 15: First floor lobby, with window at right

At the front of the lobby doorways lead into offices on either side, at the front of the building, both of which are plain rooms. The door at left in the photograph above gives access to the second staircase. The narrowness of this doorway and the steps leading to it indicate that this was not a public stairway.

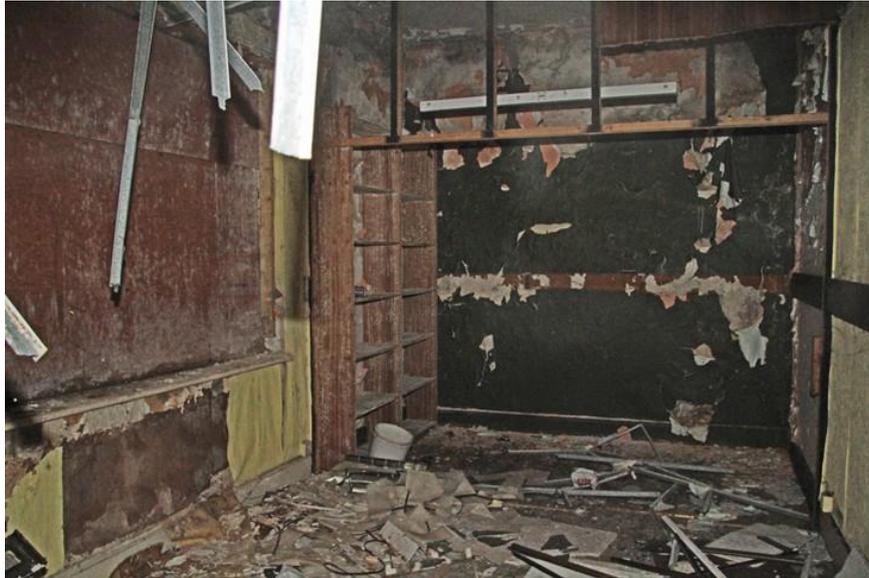
Plate 16: Office at front of first floor

The photograph above shows one of the offices at the front of the building, with the boarded-up window at left. As noted above, this is a plain room, with no decorative detailing.

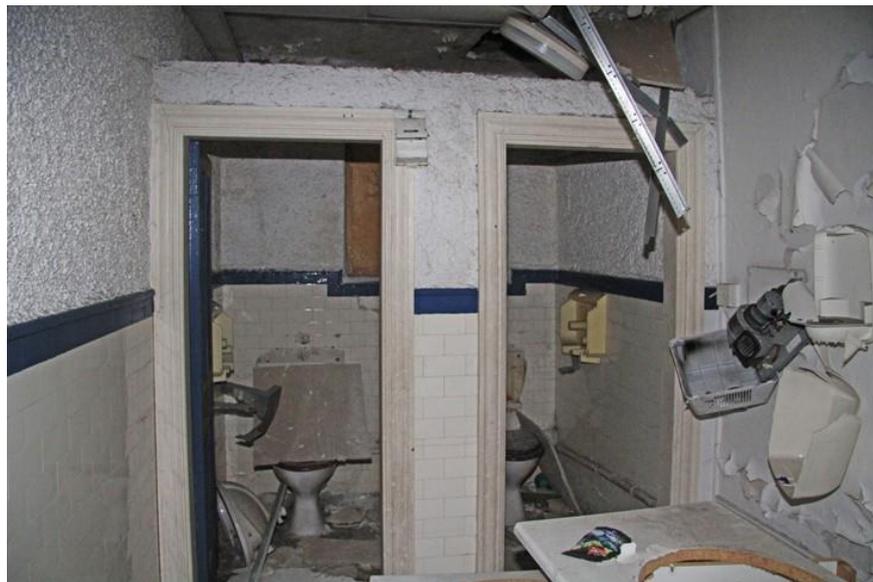
Plate 17: Toilets at first floor level

To the rear of the staircases there are toilets. The partitions have moulded timber architraves, which suggests that they are part of the original 1930s building. The sanitary ware is of more recent date, as is the counter top into which the wash basins are set. The lower parts of the walls are tiled, while the upper parts are roughcast rendered.

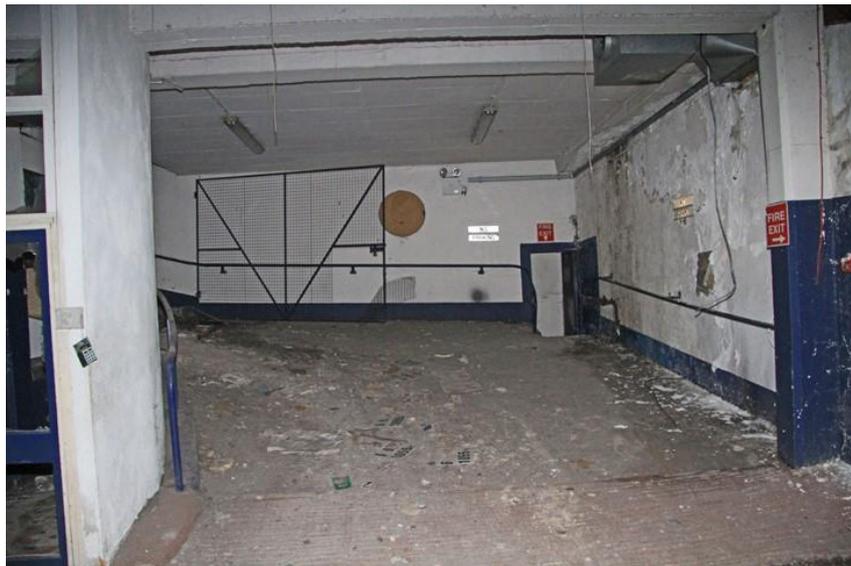
Plate 19: Concrete ramp at first floor

At the rear of the foyer there is a concrete ramp, running up towards the upper floor. This is clearly part of the 1970s conversion for use as a car showroom, at which time the concrete floors were inserted.

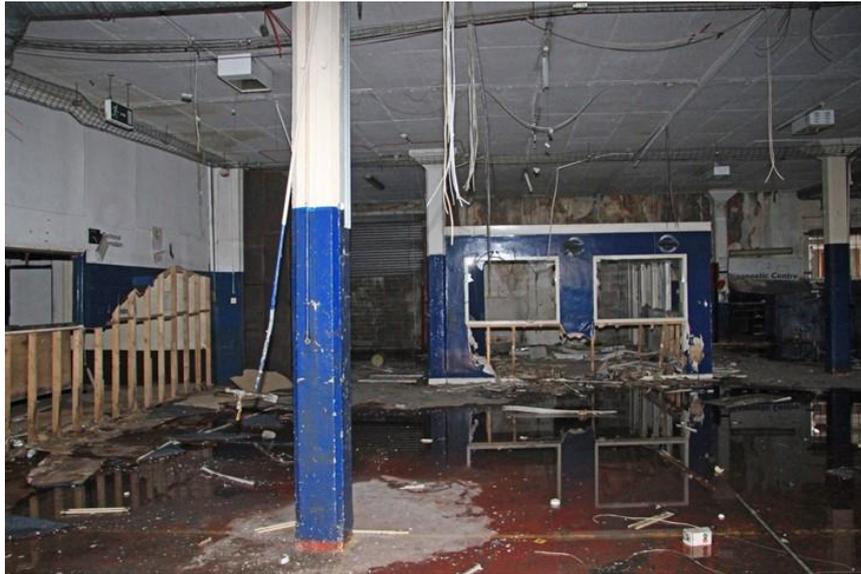
Plate 20: Office at rear of ramp

Beyond the ramp the building opens out into a large space, divided by concrete columns that support the concrete upper floor. To one side an office is partitioned off from the main floor and to the side there is a roller shutter, giving access to an external ramp, which provides access for cars to be brought up to this level.

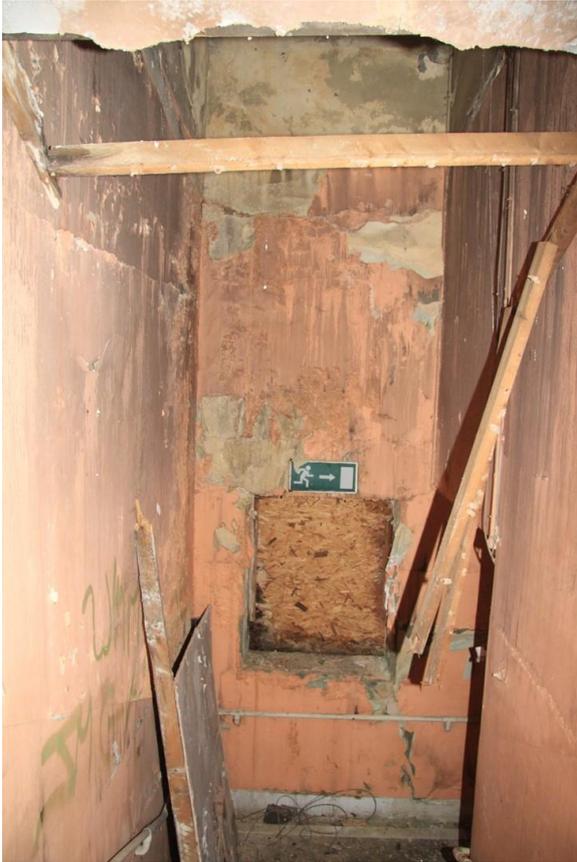
Plate 22: Secondary staircase

This is a very plain staircase, lacking the vaulting of the main stairs. It is of concrete, without the linoleum covering.

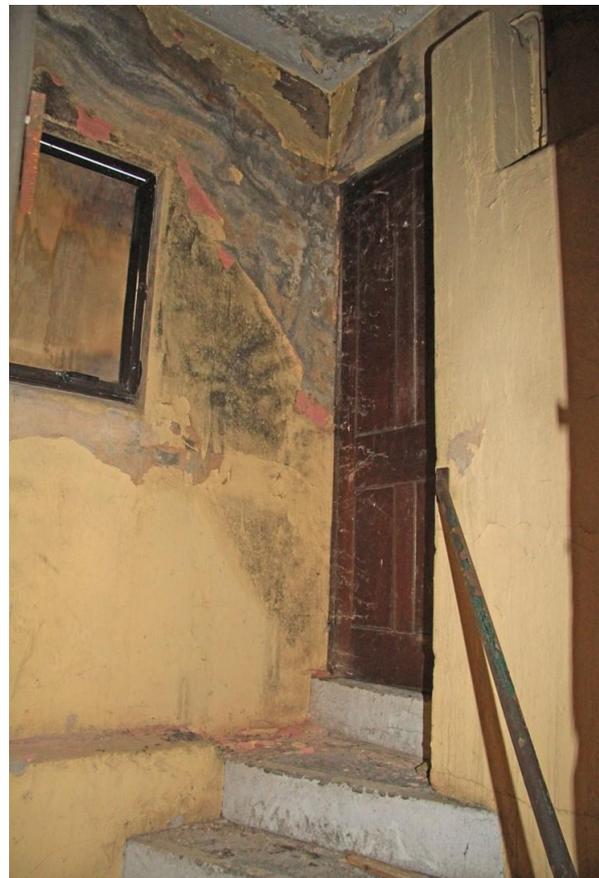
Plate 23: Door to projection room

A doorway at the top of the secondary staircase leads to a short flight of steps, set at an angle, and leading to a small door at the top. This door gave access to the projection room. No access to this room was possible during the survey, as the door was locked. A view through the keyhole indicated that there is no surviving projection equipment in the room.

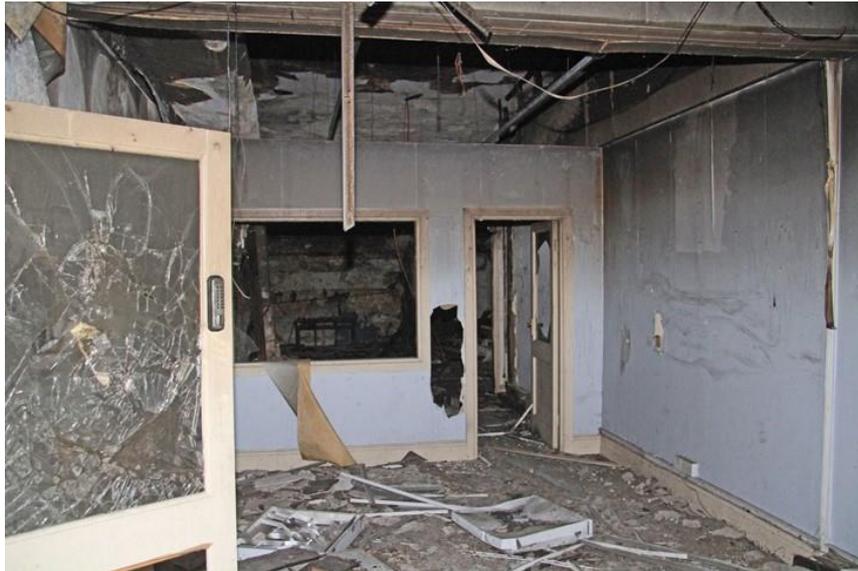
Plate 24: Offices on second floor

The secondary staircase leads to offices on the second floor. These are partitioned off from the main space and are part of the 1970s conversion to motor showroom. The floor is concrete.

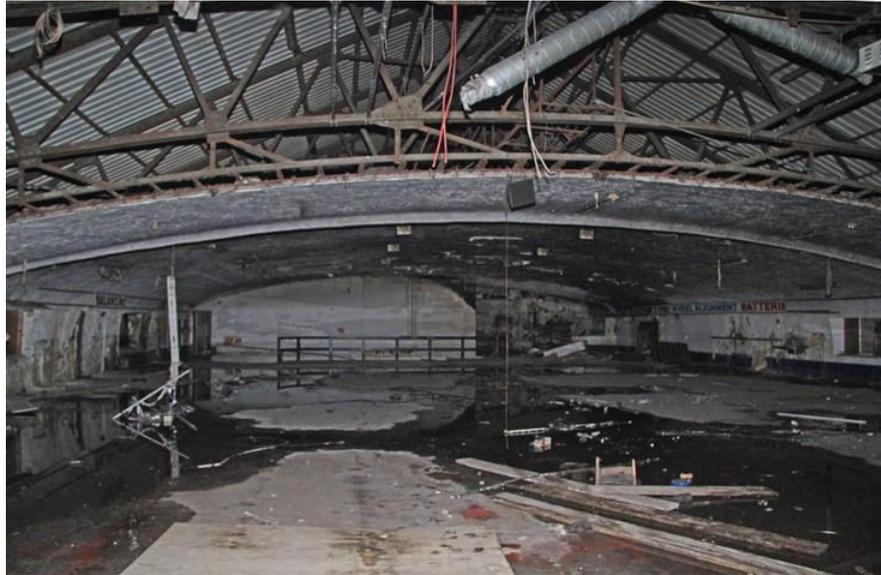
Plate 26: View to front at second floor level

At the rear of the second floor is another substantial concrete floor, accessed via the car ramp and evidently used for storing cars. The space has an arched ceiling covering most of the area, though this is missing in the rear section. The roof structure is visible and consists of steel trusses supporting a profiled steel roof above and a curved ceiling below.
